Technical Bulletin – TBN-034

Product: SIBS on Toyota Landcruiser

**Subject: Front issues on Toyota Landcruisers: steering bearings
and front CV joints.**

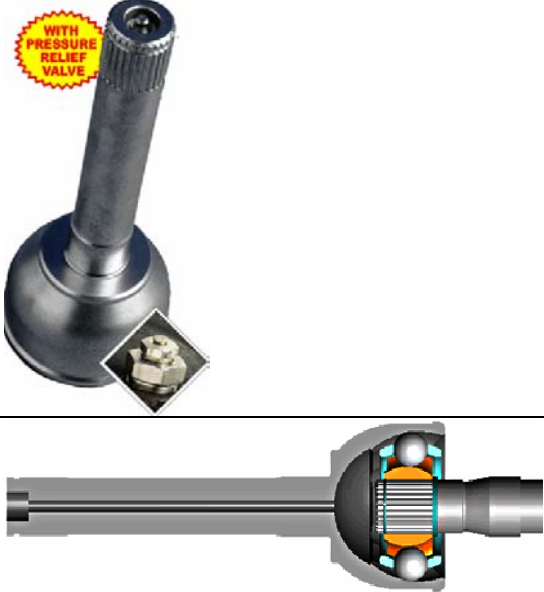
Item	Description	Photo
1	<p>Greasable front CV joint with pressure relief valve.</p> <p>ABT P/N: 24-5003 (CV Joint Front TLC79 – greasable) Note: sold individually</p> <p>A grease nipple in the end of the shaft allows for quick and effective greasing from inside the CV whilst still in the vehicle.</p> <p>Install pressure relief valve into inspection port of front knuckle. Grease CV joint regularly and watch for pop-out pin indicating knuckle is full of grease.</p>

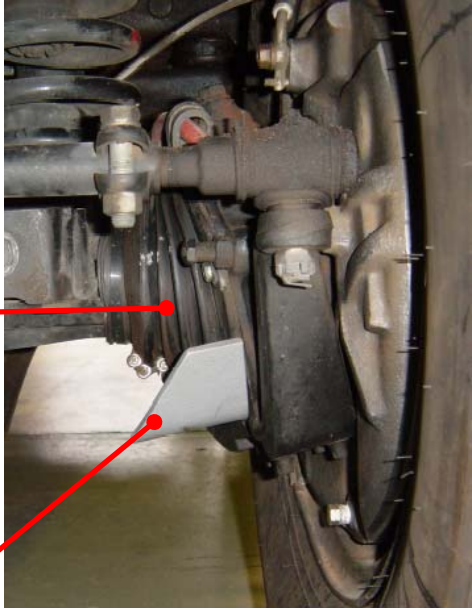
2	<p>Split rubber boot.</p> <p>ABT P/N: 24-5001 (Knuckle boot kit TLC79)</p> <p>Protects felt seal at back of knuckle and helps prevent water ingress.</p> <p>Note: this is a <u>wear</u> item and should be inspected and replaced regularly.</p>

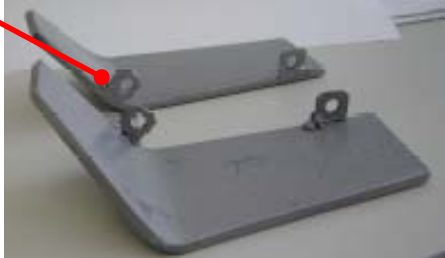
<p>4</p>	<p>Knuckle bash plates</p> <p>Split rubber boots become damaged and must be changed regularly. To increase life of the boot ABT can provide additional bash plates to deflect projectiles that may cause damage</p> <p>24-5001 Knuckle Boot Kit TLC 79</p> <p>24-5006 Front knuckle bash plates (pair). Suits TLC79.</p>

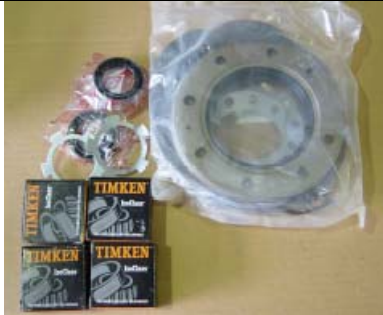
<p>5</p>	<p>Timken steering bearings</p> <p>ABT P/N: 01-6055</p> <p>Several customers have reported improved life from Timken brand bearing. The standard Toyota bearing is Koyo and many aftermarket kits will include second rate brands.</p> <p>Bearing is also available in a kit including all gaskets and shims to change and adjust steering bearings. ABT P/N: 24-4964 (Front swivel hub kit – Timken bearings)</p>
